FINAL REPORT
INVESTIGATION AND IMPROVEMENT OF THE
RELIABILITY OF THE C-141A AIRCRAFT
MASTER CAUTION CONTROL UNIT

JULY 1976

ARINC RESEARCH CORPORATION

D. Dahl

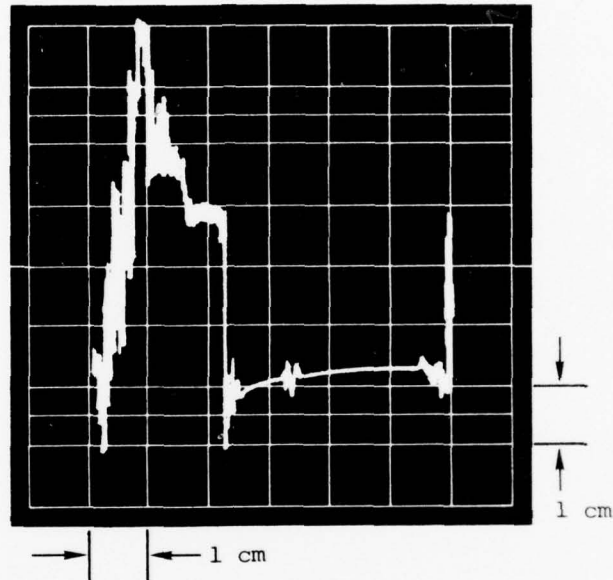
Figure 3-2. +28 VOLT INPUT LINE TO MASTER CAUTION CONTROL UNIT (MCCU)

Transients were also observed on the +28 volt line. The most significant transient waveform on the +28 volt input line to the unit appeared when the annunciator displays were flashing, the master caution light was on, and aircraft power was suddenly removed. This condition could occur when aircraft systems are actuated during ground maintenance. The peak level observed was 80 volts positive and negative for durations of approximately 50 microseconds. This was followed by a series of lower-level transients for a total of 200 microseconds. The scope display of this condition is reproduced in Figure 3-2.

Amplitude: 20 volts per centimeter
Sweep Speed: 50 microseconds per centimeter

The conditions observed during these tests at McGuire Air Force Base indicated that transient protection should be provided for the signal lines and the +28 volt bus.

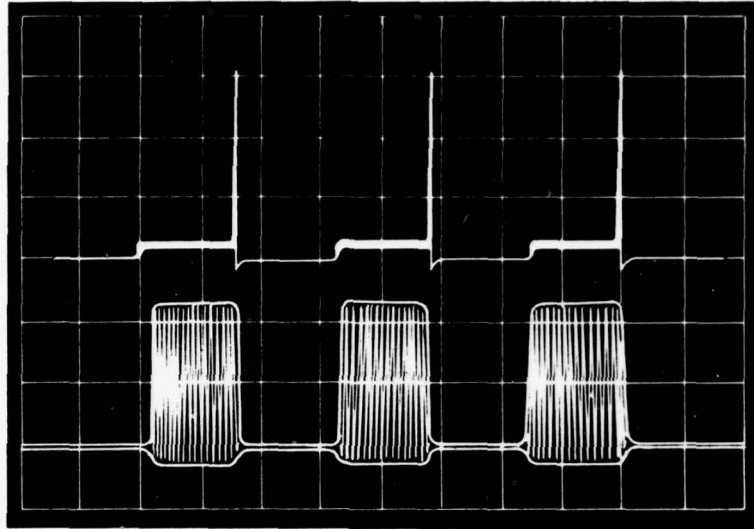
Figure 3-4. LABORATORY MOCK-UP TEST WAVEFORMS

The scope display reproduced in Figure 3-4 shows the waveforms recorded at pin 2 and pin 5 of the MCCU under test in the laboratory mock-up. The sweep speed was 0.5 second per cm and the amplitude was 100 volts power cm. The upper waveform is at the positive input (pin 2) of the unit. This duplicates the aircraft conditions, showing the +28 volt fault signal and the transient of approximately 300 volts that appears when the master caution light is pressed to clear.

Amplitude: 100 volts per centimeter
 Sweep Speed: 5 seconds per centimeter
 Upper: MCCU Pin 2 - positive-
 signal input terminal
 Lower: MCCU Pin 5 - +28 volt
 input terminal

annunciators, and then removed without clearing the master caution control lights. At the time power is removed, the inductive transient from the annunciator holding relays is present at the input to the MCCU. The transient levels and duration for this release of multiple annunciator relays cannot be reliably predicted, since individual transients are combined to cause the overall transient. They were observed on the aircraft to be higher in some instances than the transients developed during laboratory testing. They also vary from aircraft to aircraft, as well as from occurrence to occurrence, depending on aircraft wiring variations and the number and position of annunciators activated. The laboratory tests permitted the selection of transient-protection components that can adequately suppress all observed transients with a substantial safety margin.

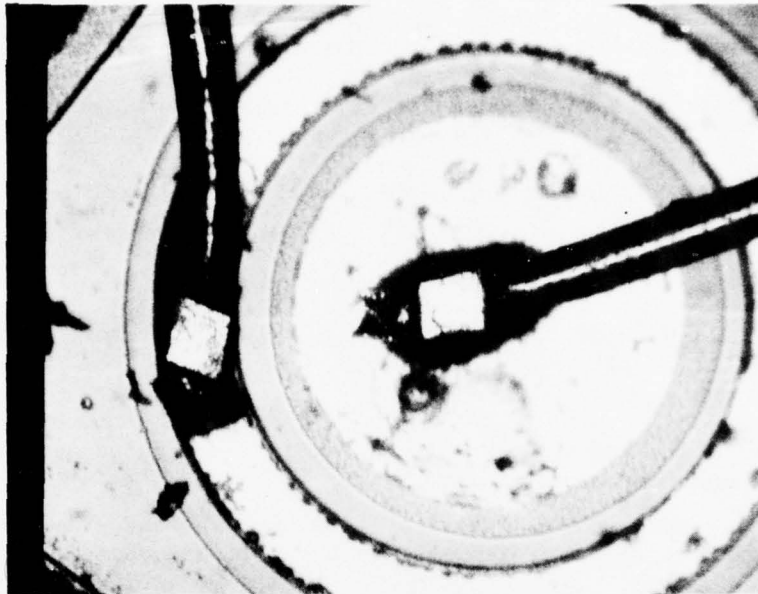
The transistor examination revealed evidence of a failure mode that consisted of concentrated temperature extremes in the emitter contact area. The photographs of Figure 3-6 show the typical failure mechanism seen in the transistors examined.

(a) Hot spot shown just below emitter terminal

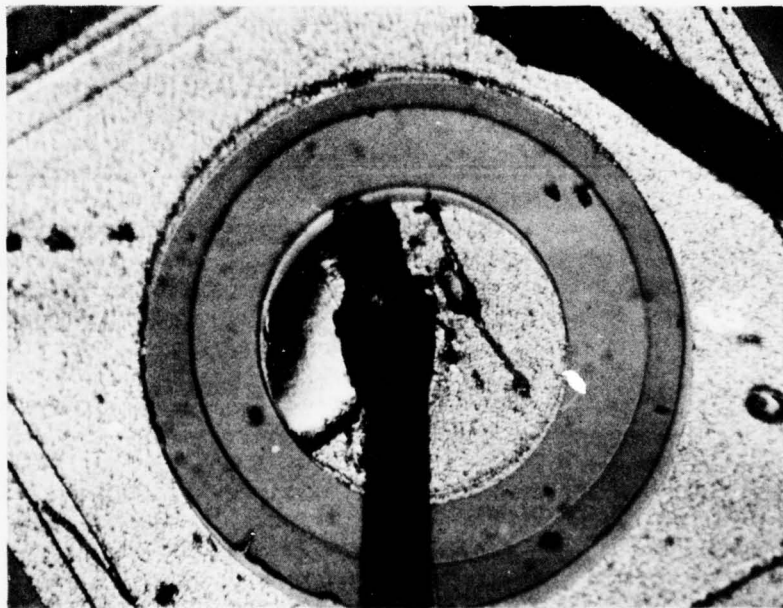
Examination of the failed transistors also revealed significant differences in physical construction and semiconductor geometry from manufacturer to manufacturer. Three different structural designs were found in the eight failed transistors examined, as shown in Figure 3-6. Although this effort did not permit detailed evaluation of the influence of these differences, it is believed that such differences in geometry produce significant variations in performance parameters.

(b) Melted area to left of emitter terminal

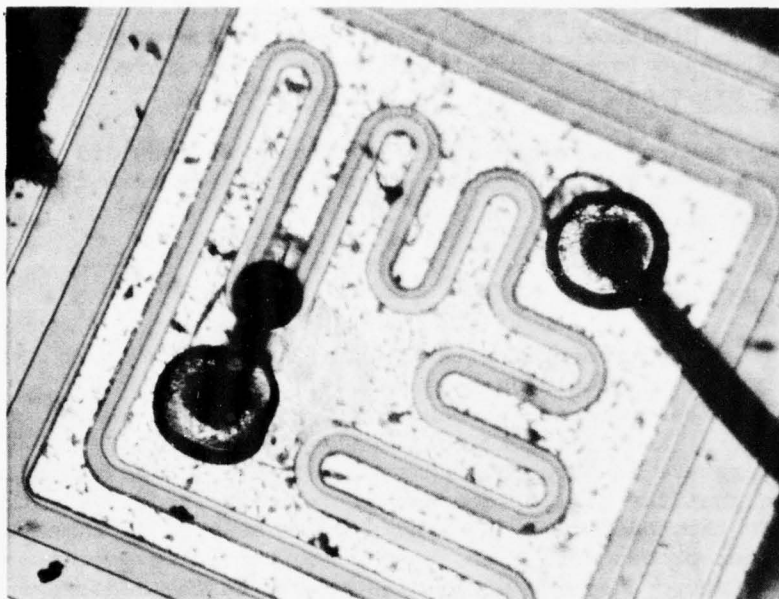
We conducted a laboratory test to identify the levels required to duplicate the observed transistor failure characteristic. The tests used a common emitter circuit, a 3000-ohm collector load resistor with 80-volt collector supply voltage, and a base signal of 1.0-microsecond pulse width at a pulse-recurrence frequency of 2.2 milliseconds (455 Hz) and with an amplitude variable from zero to -28 volts. The transistor failed immediately when the base signal pulse amplitude was increased to about -15 volts peak level. Subsequent measurement indicated that the transistor failed with a collector-emitter short. Examination of the semiconductor revealed the characteristic hot spot on the emitter surface.

(c) Emitter terminal burned off near semiconductor connection; hot spot shown just above the emitter terminal

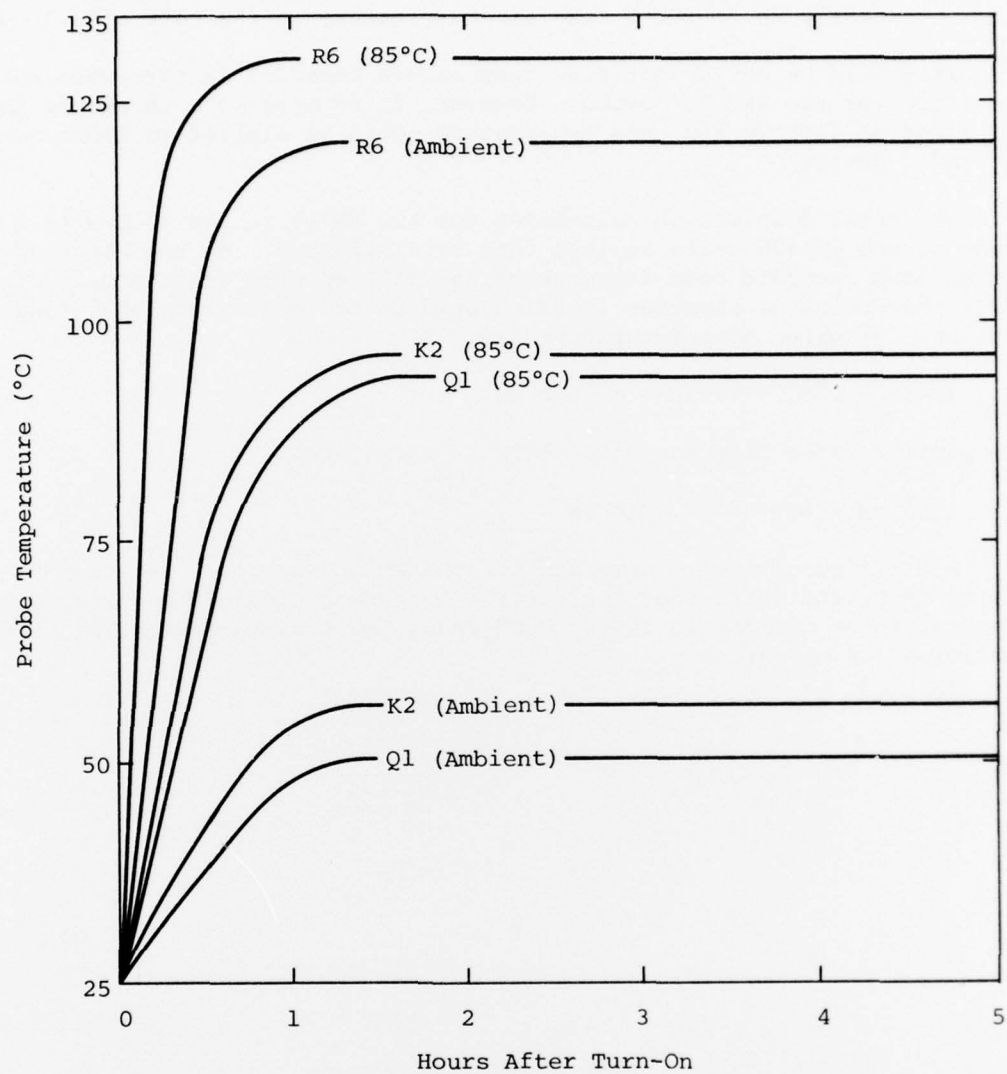
Figure 3-7. THERMAL MEASUREMENTS

The primary purpose of the thermal measurements was to identify possible stress levels on transistor Q1. A review of available data on thermal characteristics of transistors used in the MCCU revealed the following:

Similar results were obtained for the 2N3063 device. The thermal measurements indicated that there were no thermal problems associated with transistors or components in the MCCU under the most severe anticipated conditions of operation.
